2002 Annual Compliance Report Mexican Hat, Utah, Disposal Site

Compliance Summary

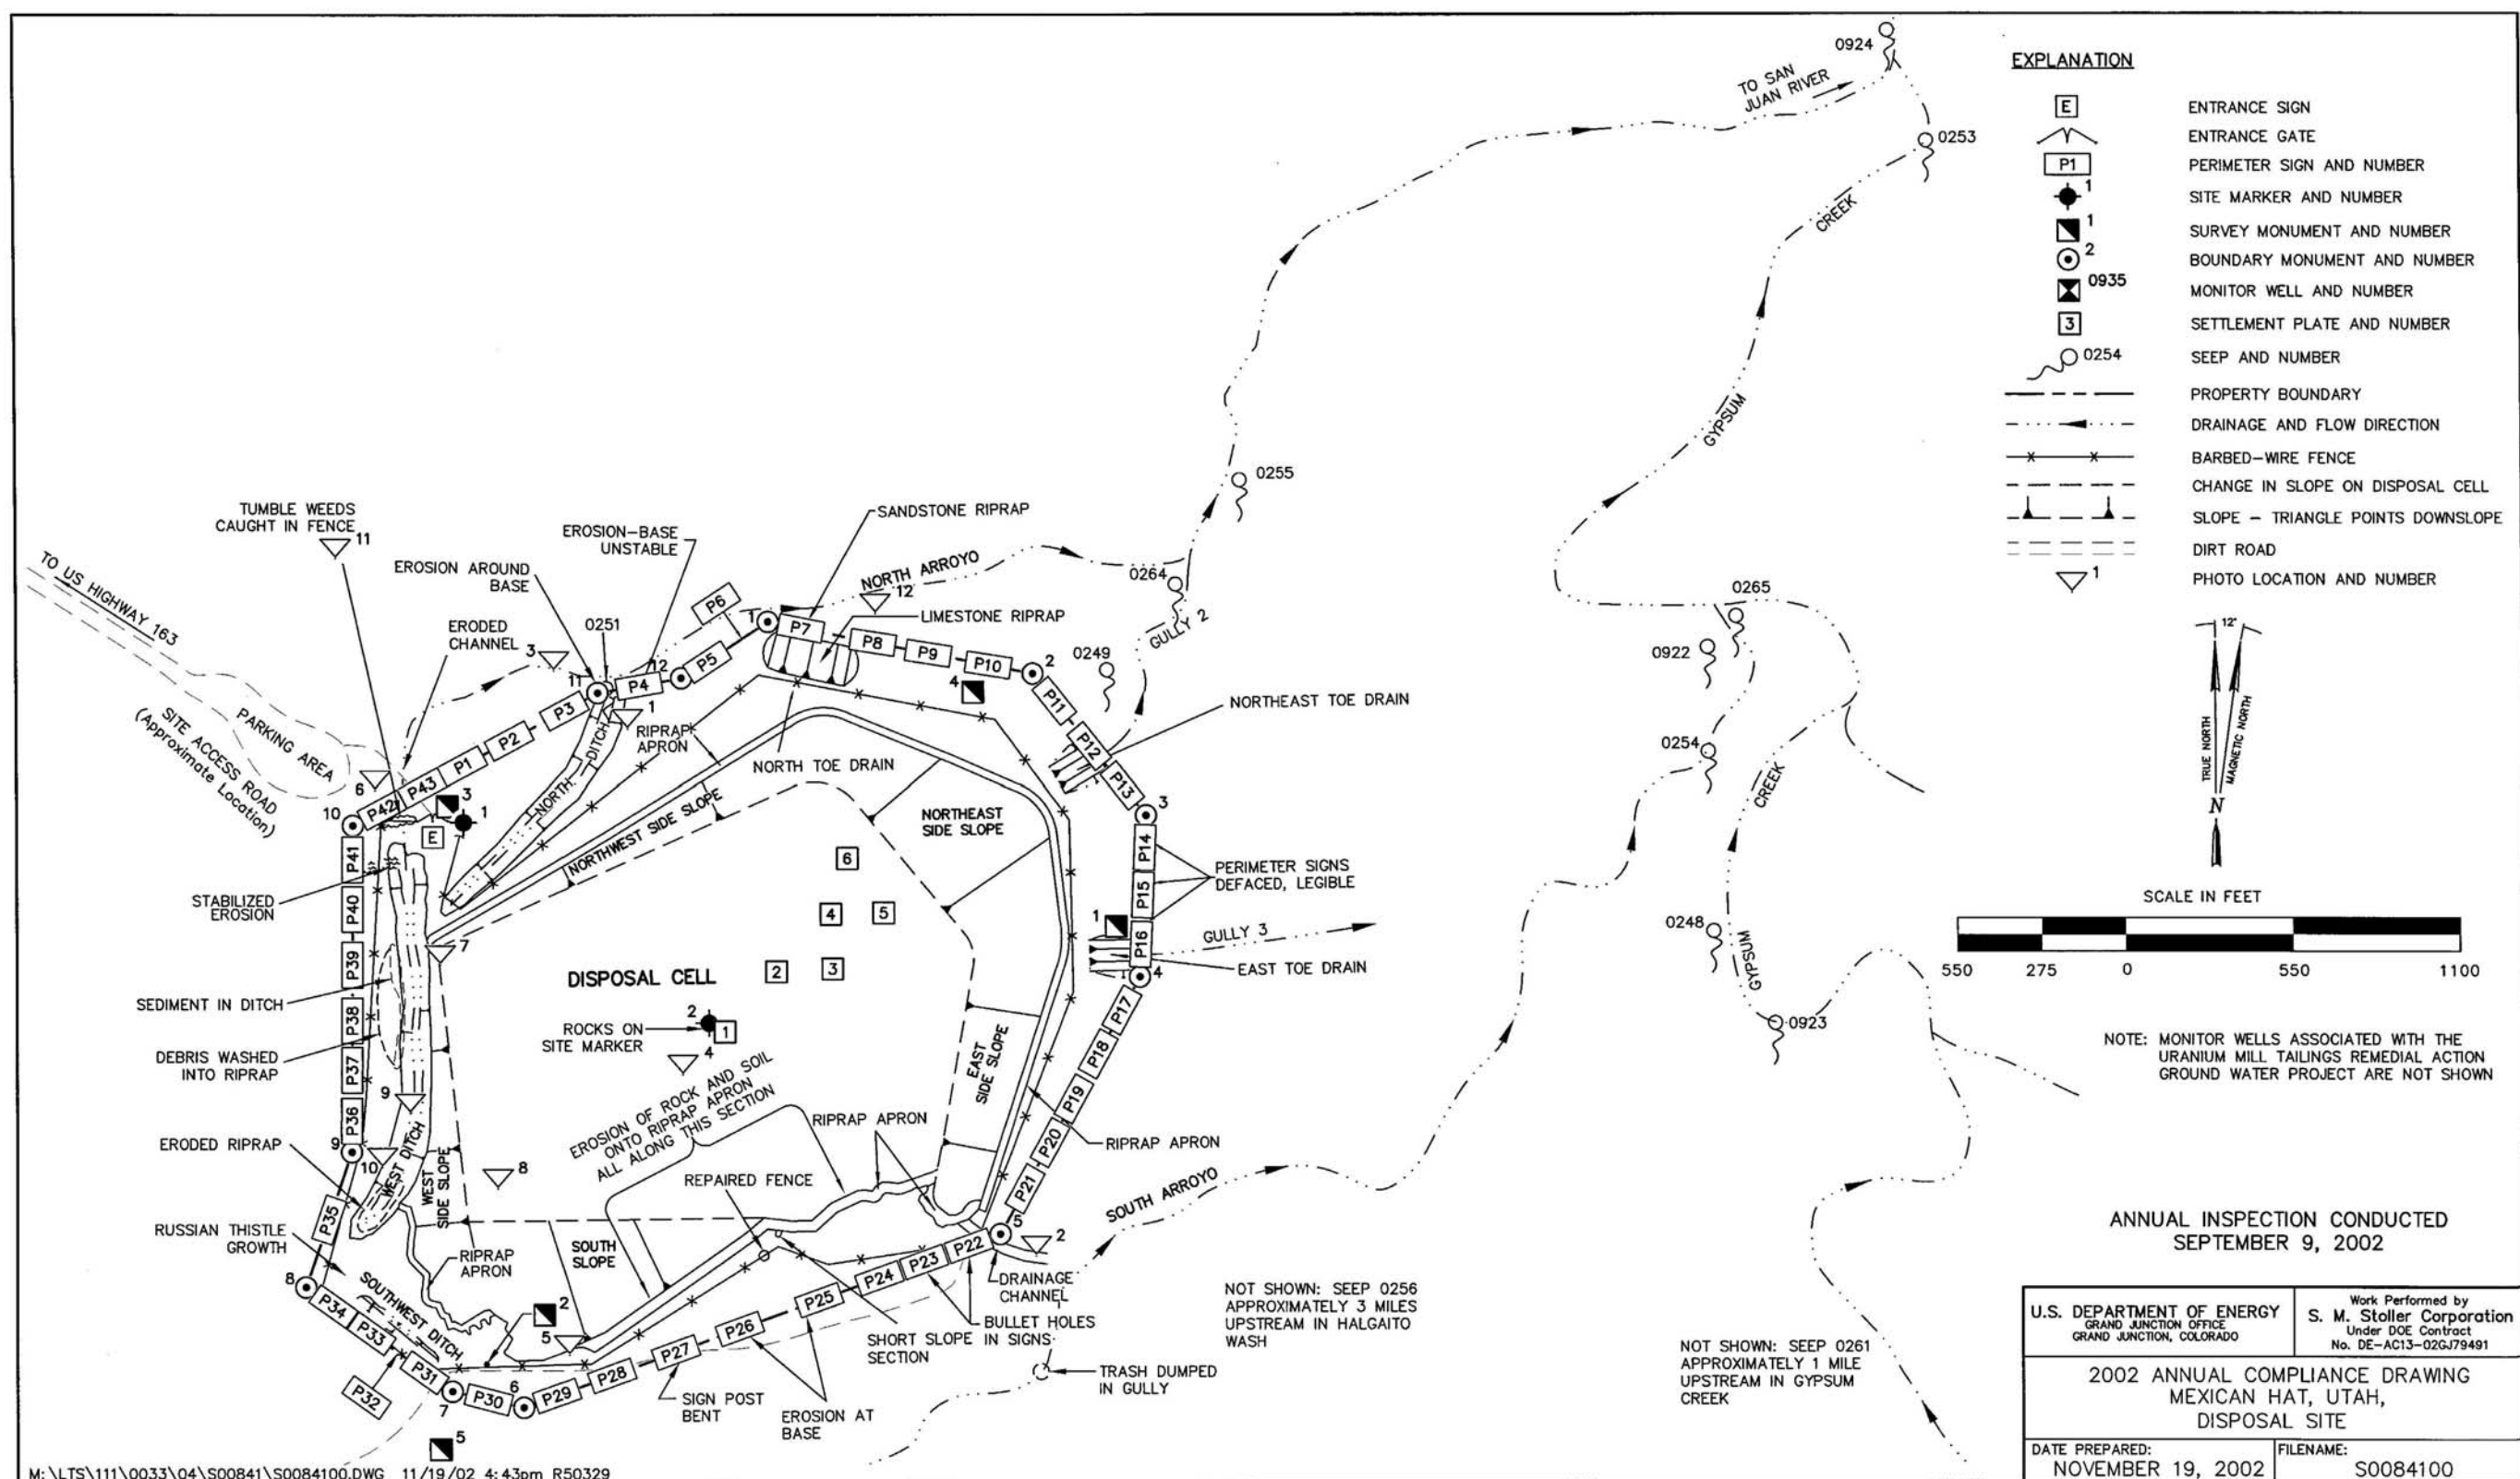
Figure 12-1. 2002 Annual Compliance Drawing for the Mexican Hat, Utah, Disposal Site

The site, south of Mexican Hat, Utah, was inspected on September 9, 2002. Results of the inspection are described below. Features and photograph locations (PLs) mentioned in this report are shown on Figure 12–1. Numbers in the left margin of this report refer to items summarized in the Executive Summary table.
